CHAPTER 1

OVERVIEW

1.1. INTRODUCTION

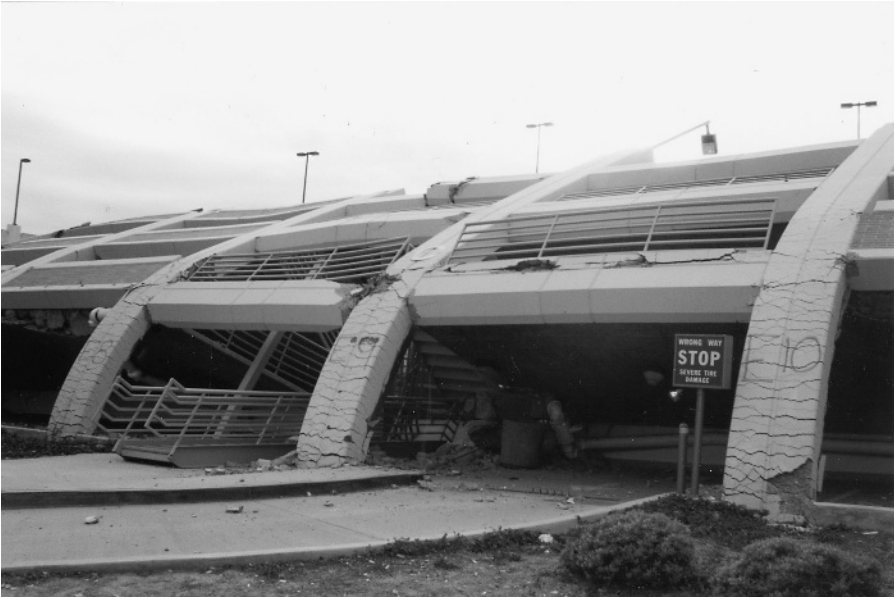
Figure 1.1 Parking structure that collapsed during the 1994 Northridge earthquake, California State University, Northridge Campus.

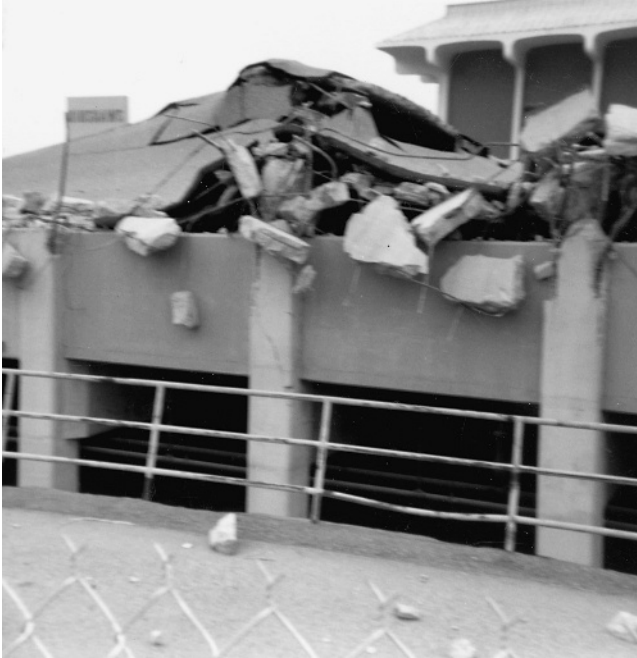
Figure 1.3 Detail of parking structure that collapsed during the Whittier Narrows earthquake of 1987.

performed well in seismic events and coming up with improved versions capable of standing up to a certain level of earthquakes. (See Figures 1.2 and 1.3.)

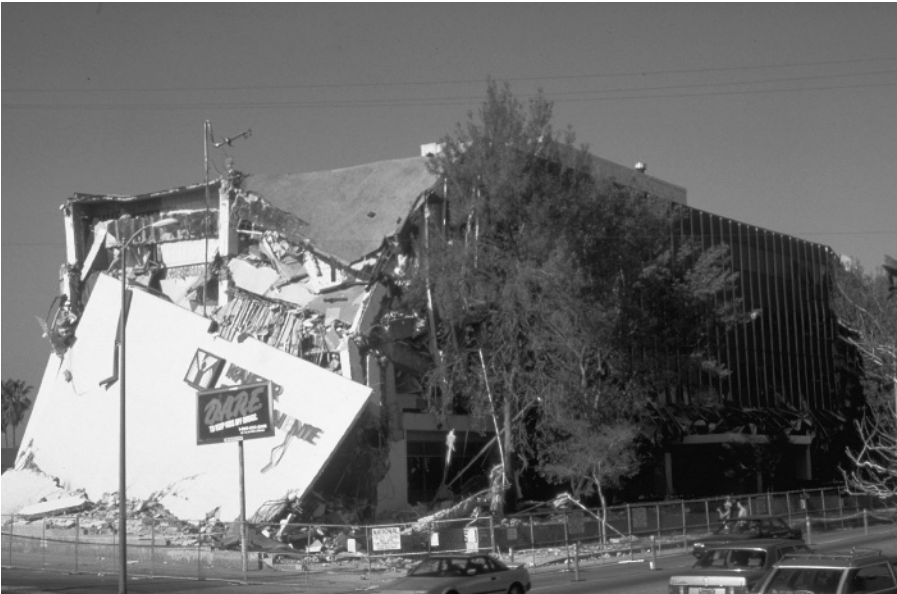
Figure 1.7 Northridge earthquake, 1994. Collapsed end shear wall, Kaiser Permanente Office Building, Granada Hills, CA. (Photo courtesy of the University of California Library at Berkeley.)

earthquake-generated ground acceleration data at the base of an actual structure. Rapid and violent oscillations of the moment frame exceeding 2 Hz (cycles per second) will cause the end shear wall to bend back and forth until it breaks at the base. This was the case of the Kaiser Office Building in Granada Hills during the 1994 Northridge earthquake. Once the end shear walls are destroyed, the building is susceptible to catastrophic failure. It is estimated that 80% of high-rise hospital structures in California have this type of construction.

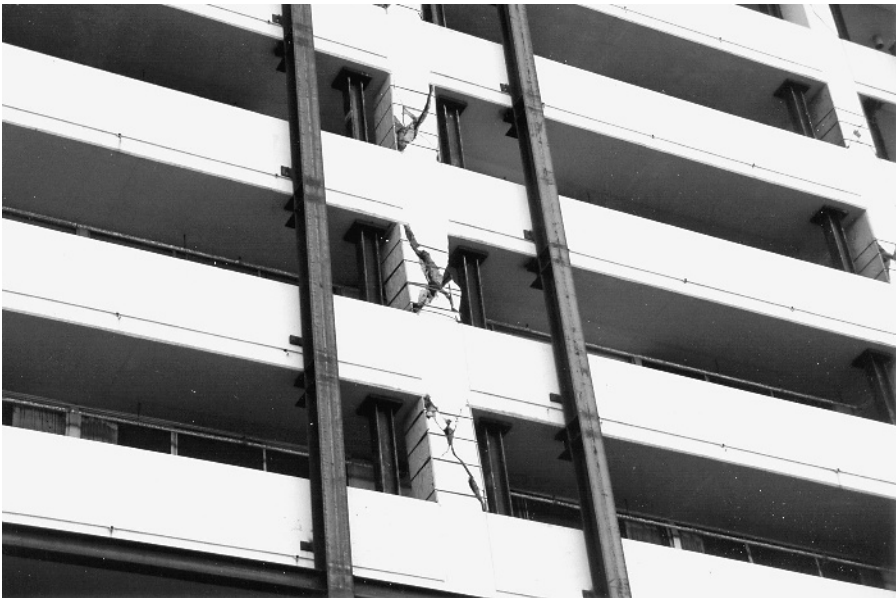
Figure 1.9 Reinforced-concrete columns severely damaged in the Northridge earthquake, Champagne Towers, Santa Monica, CA.

Champagne Towers, an upscale high-rise apartment building overlooking the Santa Monica Bay in Southern California was built utilizing a similar system, that is, end shear walls in the short direction and reinforced-concrete moment frames acting in the long direction of the structure. When the 1994 Northridge earthquake hit, residents of the towers woke up to a frightening sound and violent ground shaking accompanied by lateral sway. Initially not all that significant, within seconds the sway turned violent and uncontrollable followed by the sound of an explosion when the concrete columns broke up (Figure 1.9). The alarmed residents fled the building. The first daylight revealed severe damage to the main load-bearing columns with diagonal cracks up to $\frac{1}{2}$ in. Within hours the building was declared dangerous, uninhabitable, and condemned.

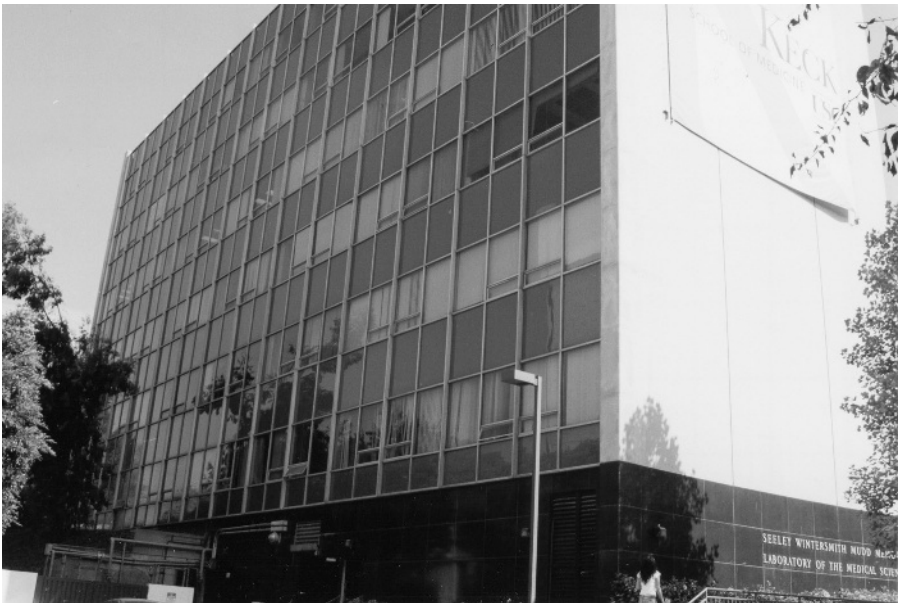
Figure 1.10 It is estimated that 80% of hospital structures in California are of the moment frame–shear wall type of construction, a bad design arrangement to resist a strong earthquake.

single layer of vertical reinforcement is provided for the wall and it is traditionally placed at the theoretical elastic centerline of the wall, thereby offering poor resistance to out-of-plane bending (Figure 1.10).

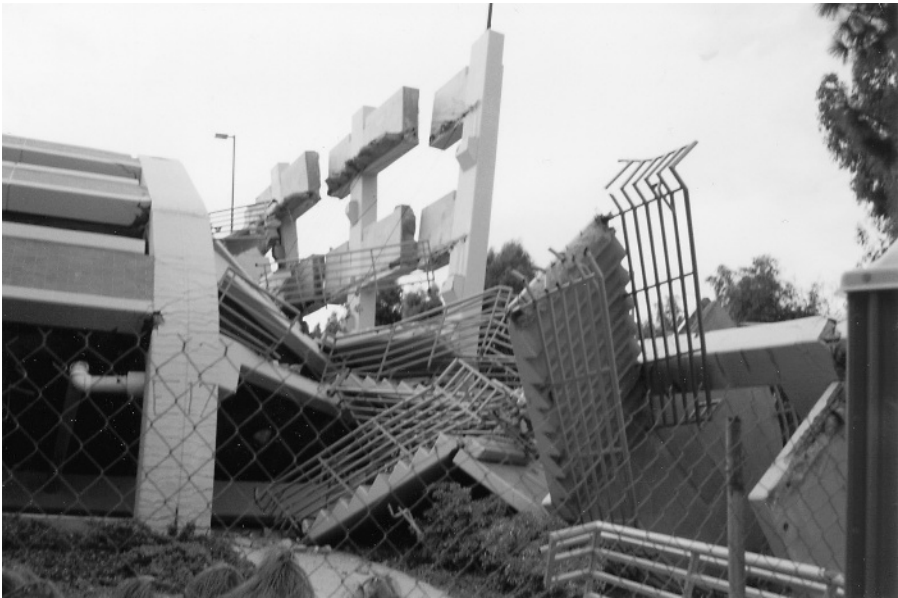
Figure 1.14 California State University parking structure. A corner of the cast-in-place framework was pulled in by the collapsed interior of the multistory structure during the 1994 Northridge earthquake.

3. *Dry-Jointed Connections in Precast Parking Structures without Monolithic Connections* An example of this type of construction was the California State University precast parking structure located near the epicenter of the 1994 Northridge earthquake (Figure 1.14). Being dry jointed, that is, the precast beams were supported on corbels of the equally precast concrete columns without monolithic connection, the structure relied on friction of the support reaction created by gravity forces (mostly dead weight) across a few inches of seating.

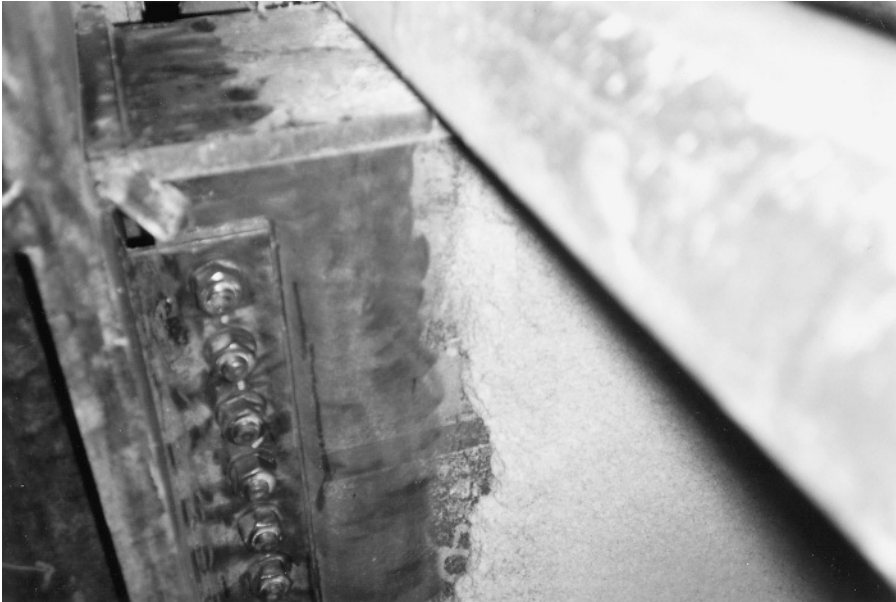
Figure 1.15 Left: crack in beam web during the Northridge earthquake, Anthony Building, Department of Water and Power, Los Angeles County.

Such reserves are provided by the moment of resistance of the shear tab by utilizing resistance of the bolts. When the *friction grip bolts* slip to form a couple, the bolts begin exerting an excessive force on the shear tab. Not meant for such extreme use (or misuse), the hardened high-strength bolts split the shear tab. The author observed such damage during the postearthquake retrofitting of the Anthony Building, head office and control building for the Los Angeles County Water and Power utility (Figure 1.15).

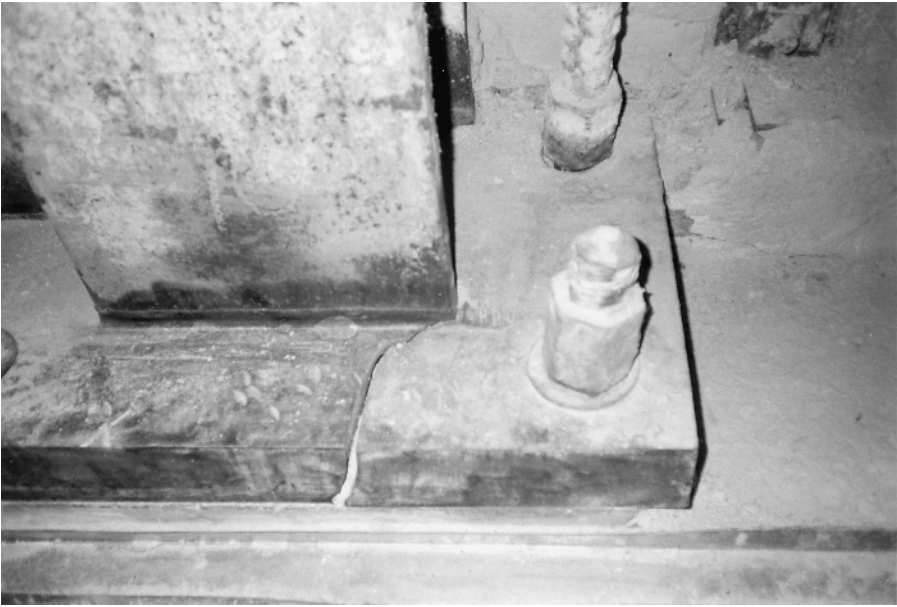
Figure 1.16 Cracks in 4-in.-thick base plates during the Northridge earthquake, Oviatt Library Annex Building.

The damage to the concentric braced frames of the Oviatt Library Annex in the California State Northridge Campus, California, is a clear demonstration of the lack of shock-absorbing properties of this type of structure (Figures 1.16 and 1.17).

The 4-in.-thick base plates connecting the Oviatt Library Annex structure to its foundation, behaving like glass, cracked and failed in brittle fracture. In addition to splitting the plates horizontally, as shown in Figure 1.16, a punching shear failure started to develop around the perimeter of the frame

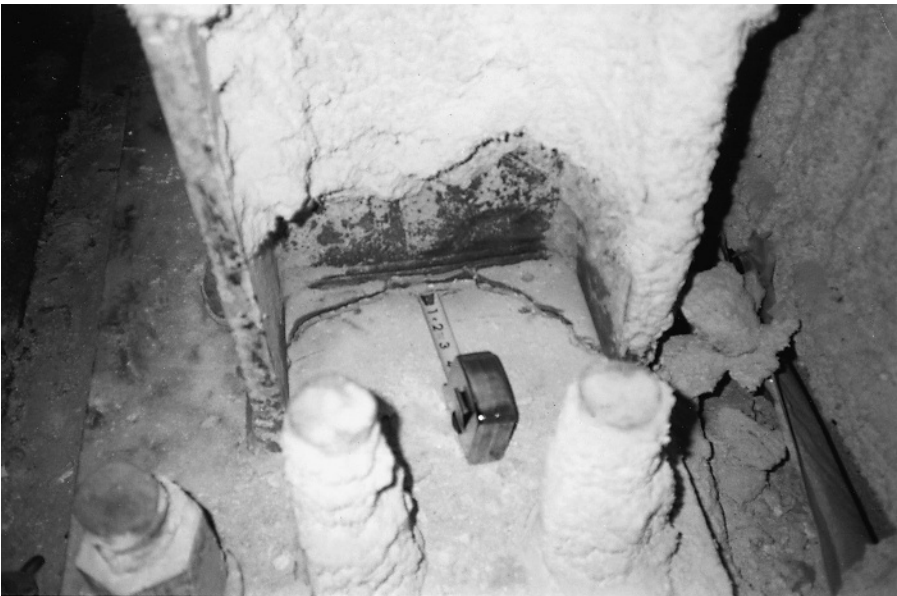
Figure 1.17 Shear failure at perimeter of frame leg–base plate solidly welded connection, Oviatt Library Annex Building. Note the crack in the center and the initial stage of shear failure on the left.

leg–base plate solidly welded connection. Torn from its footings, this rather slender structure would have overturned had the earthquake lasted a bit longer.

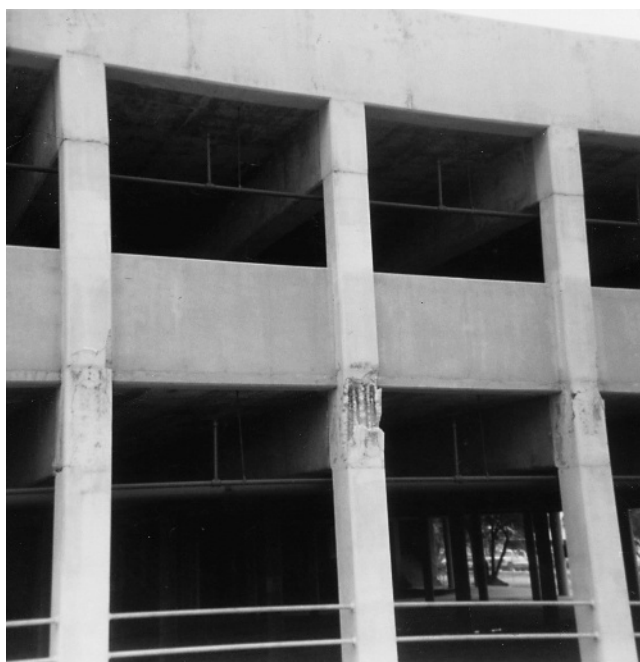
Figure 1.18 Initial stages of column joint degradation in the progressive failure of a fashion center parking structure in the Whittier Narrows earthquake, 1987.

An example of the nonductile performance of the reinforced-concrete moment-resisting frame was a fashion center parking structure in the Whittier Narrows earthquake of 1987 in California (Figures 1.18–1.20). The author established that, during each aftershock, the large, rapidly reversed horizontal shear forces produced a grinding action at the beam–column joint that pulverized the concrete until it totally disappeared. Once the concrete was gone, the slender rebars, lacking lateral confinement, could no longer support the weight of the massive concrete floor structure and buckled.

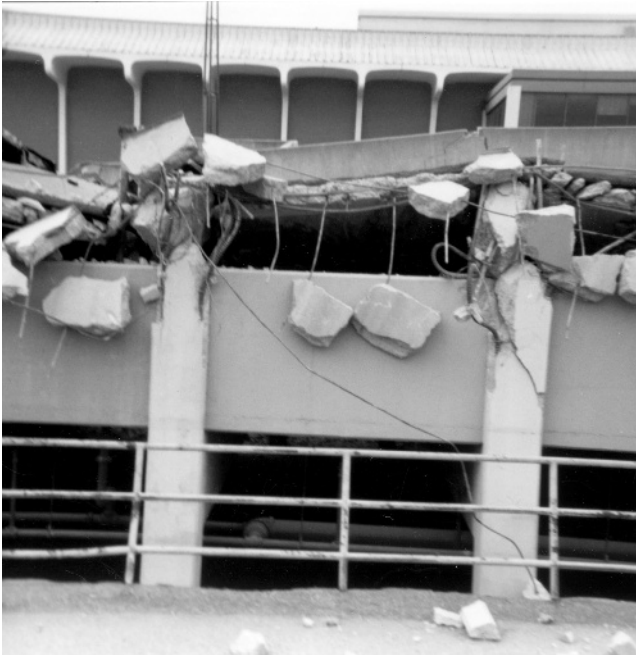
Figure 1.19 Exterior columns that supported the second floor broke at the second-floor beam–column intersection, fashion center parking structure.

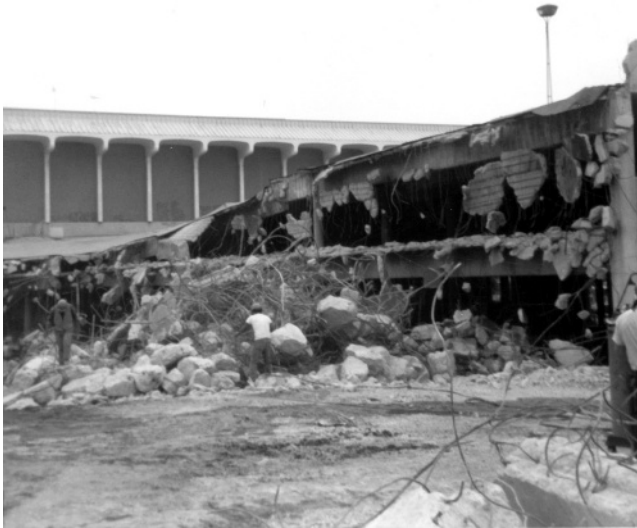
Figure 1.20 Collapsed upper floor and a large portion of the collapsed parking structure, later demolished, Whittier Narrows earthquake, 1987.
